PTO On New Holland TS100

Aim of the Project

The Aim of the project is to identify and fix the problem which wouldn't allow the PTO (Power Take Off) to spin on the New Holland TS100.

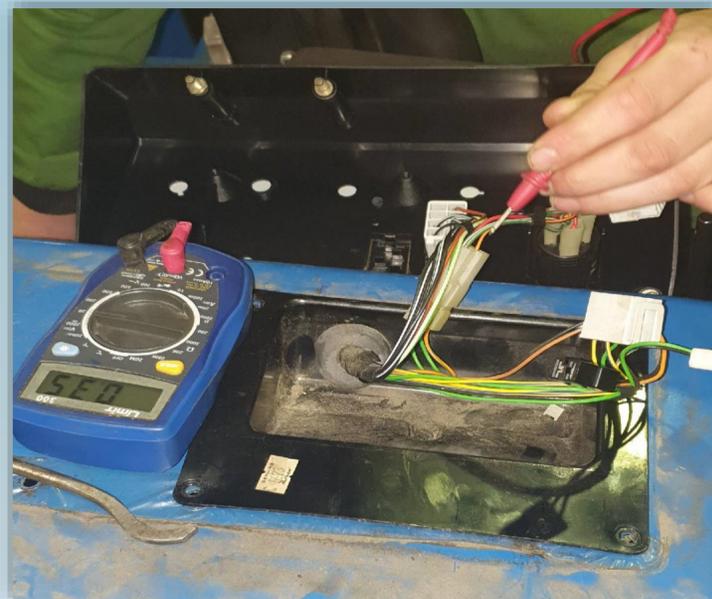
Photo of: Test of PTO Switch.

In order to test the PTO switch in the cab of the tractor we needed to remove the panel where the switch was located this gave us access to terminals on the switch. We then set a multimeter to voltage and tested each terminal on the switch and compared our values to the TS100 manual.

We found no issues with the current flowing from the switch, so we ruled out a problem with the switch. As we had the panel off, we checked to see if there was any problem with the wiring using the manual as a reference. We also found no issue there.

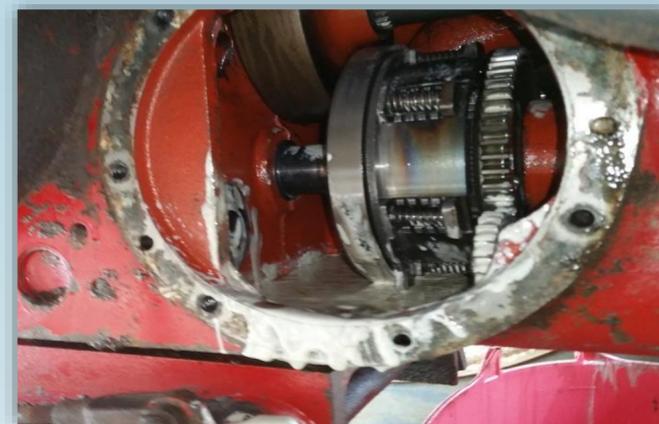
Photo of PTO clutch pack.

After pressuring testing the pack and comparing the values to manual, we found that the clutch pack was in perfect working order so that wasn't the issue with the PTO not operating.

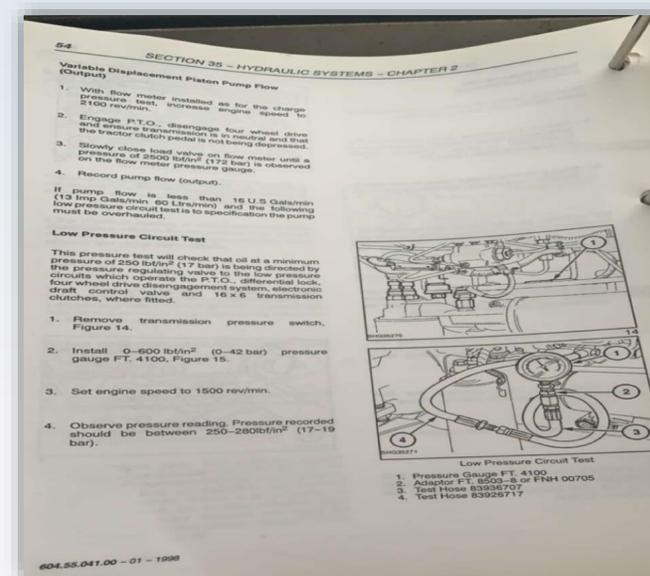
Photo of: How to conduct Pressure test from manual.

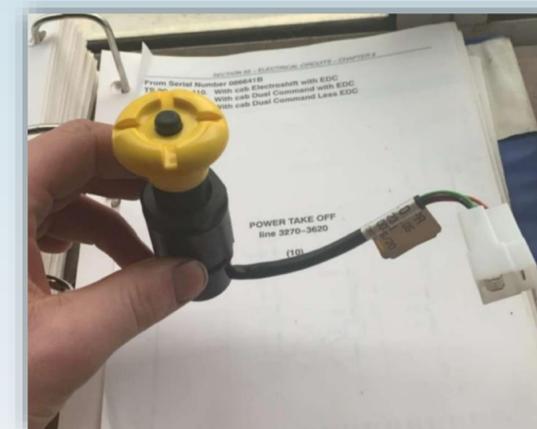
From preform the test of the switch and the PTO pack we had no idea what was wrong with the TS100. We then decided to have another look at the switch we then took apart the switch to look at the internals to ensure nothing was seized inside the switch.

We noticed that there is a central button in the switch which acts as a safety measure that had become stuck from use. We managed to release the center button from the switch, and we were able to engage the PTO. In order to prevent this from happening we ordered a replacement PTO switch for the tractor and fitted it.
